# Navajo Abandoned Uranium Mine Site Screen Report

## Section 32 AUM Site

### Navajo AUM Eastern Region

**May 2009**

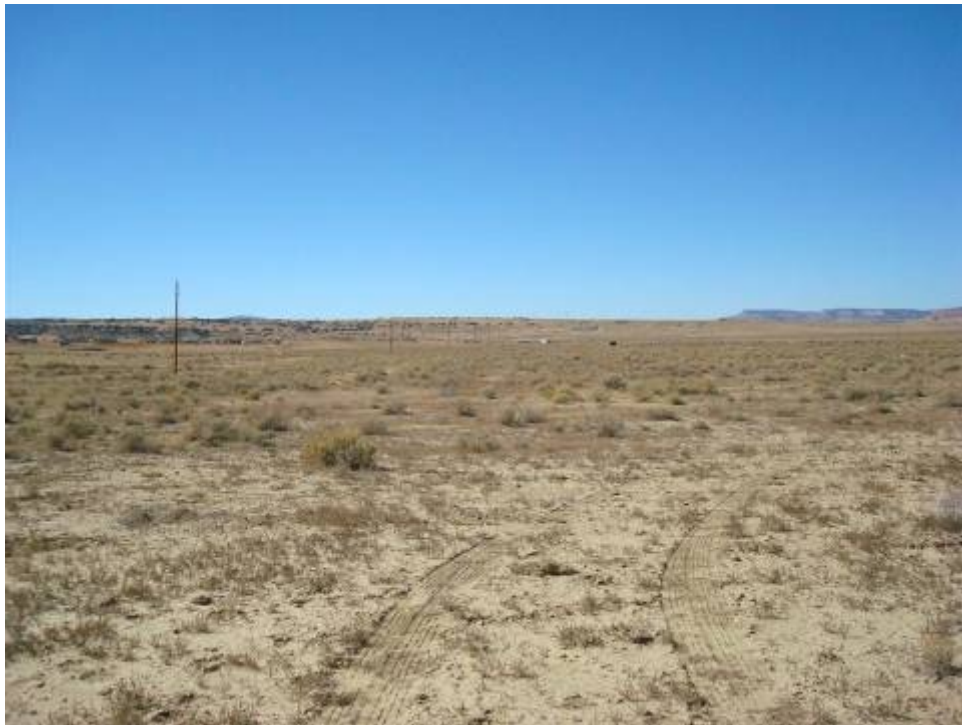
Photo 1. Section 32 Mine site, towards the west, residence in background

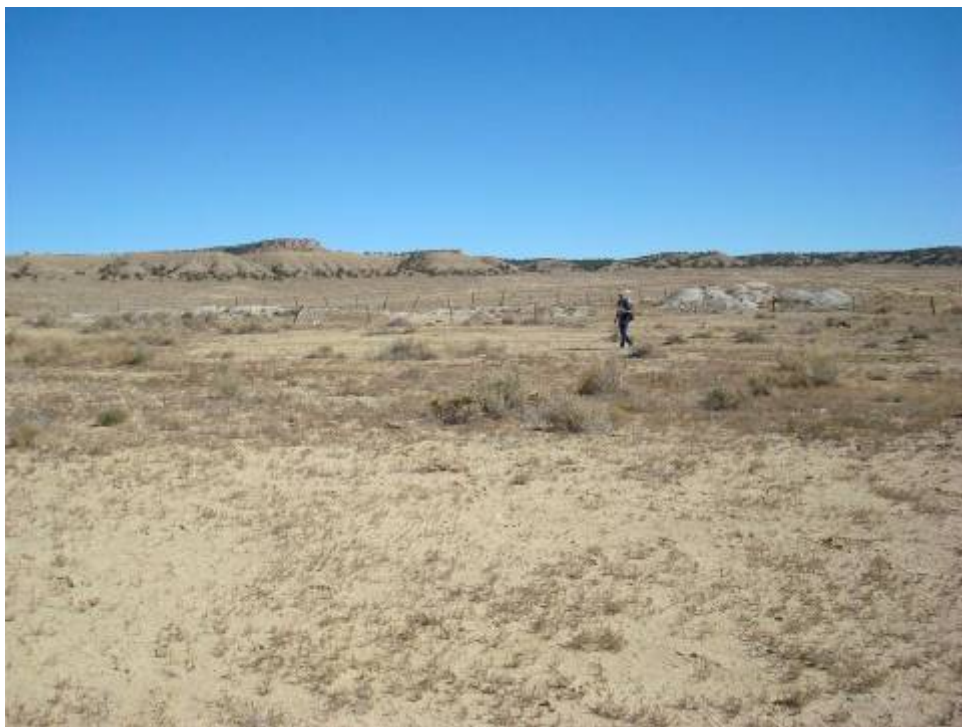
Photo 2. Section 32 Mine site, towards the south east.  
waste piles in background are located on adjoining Section 33 Mine site

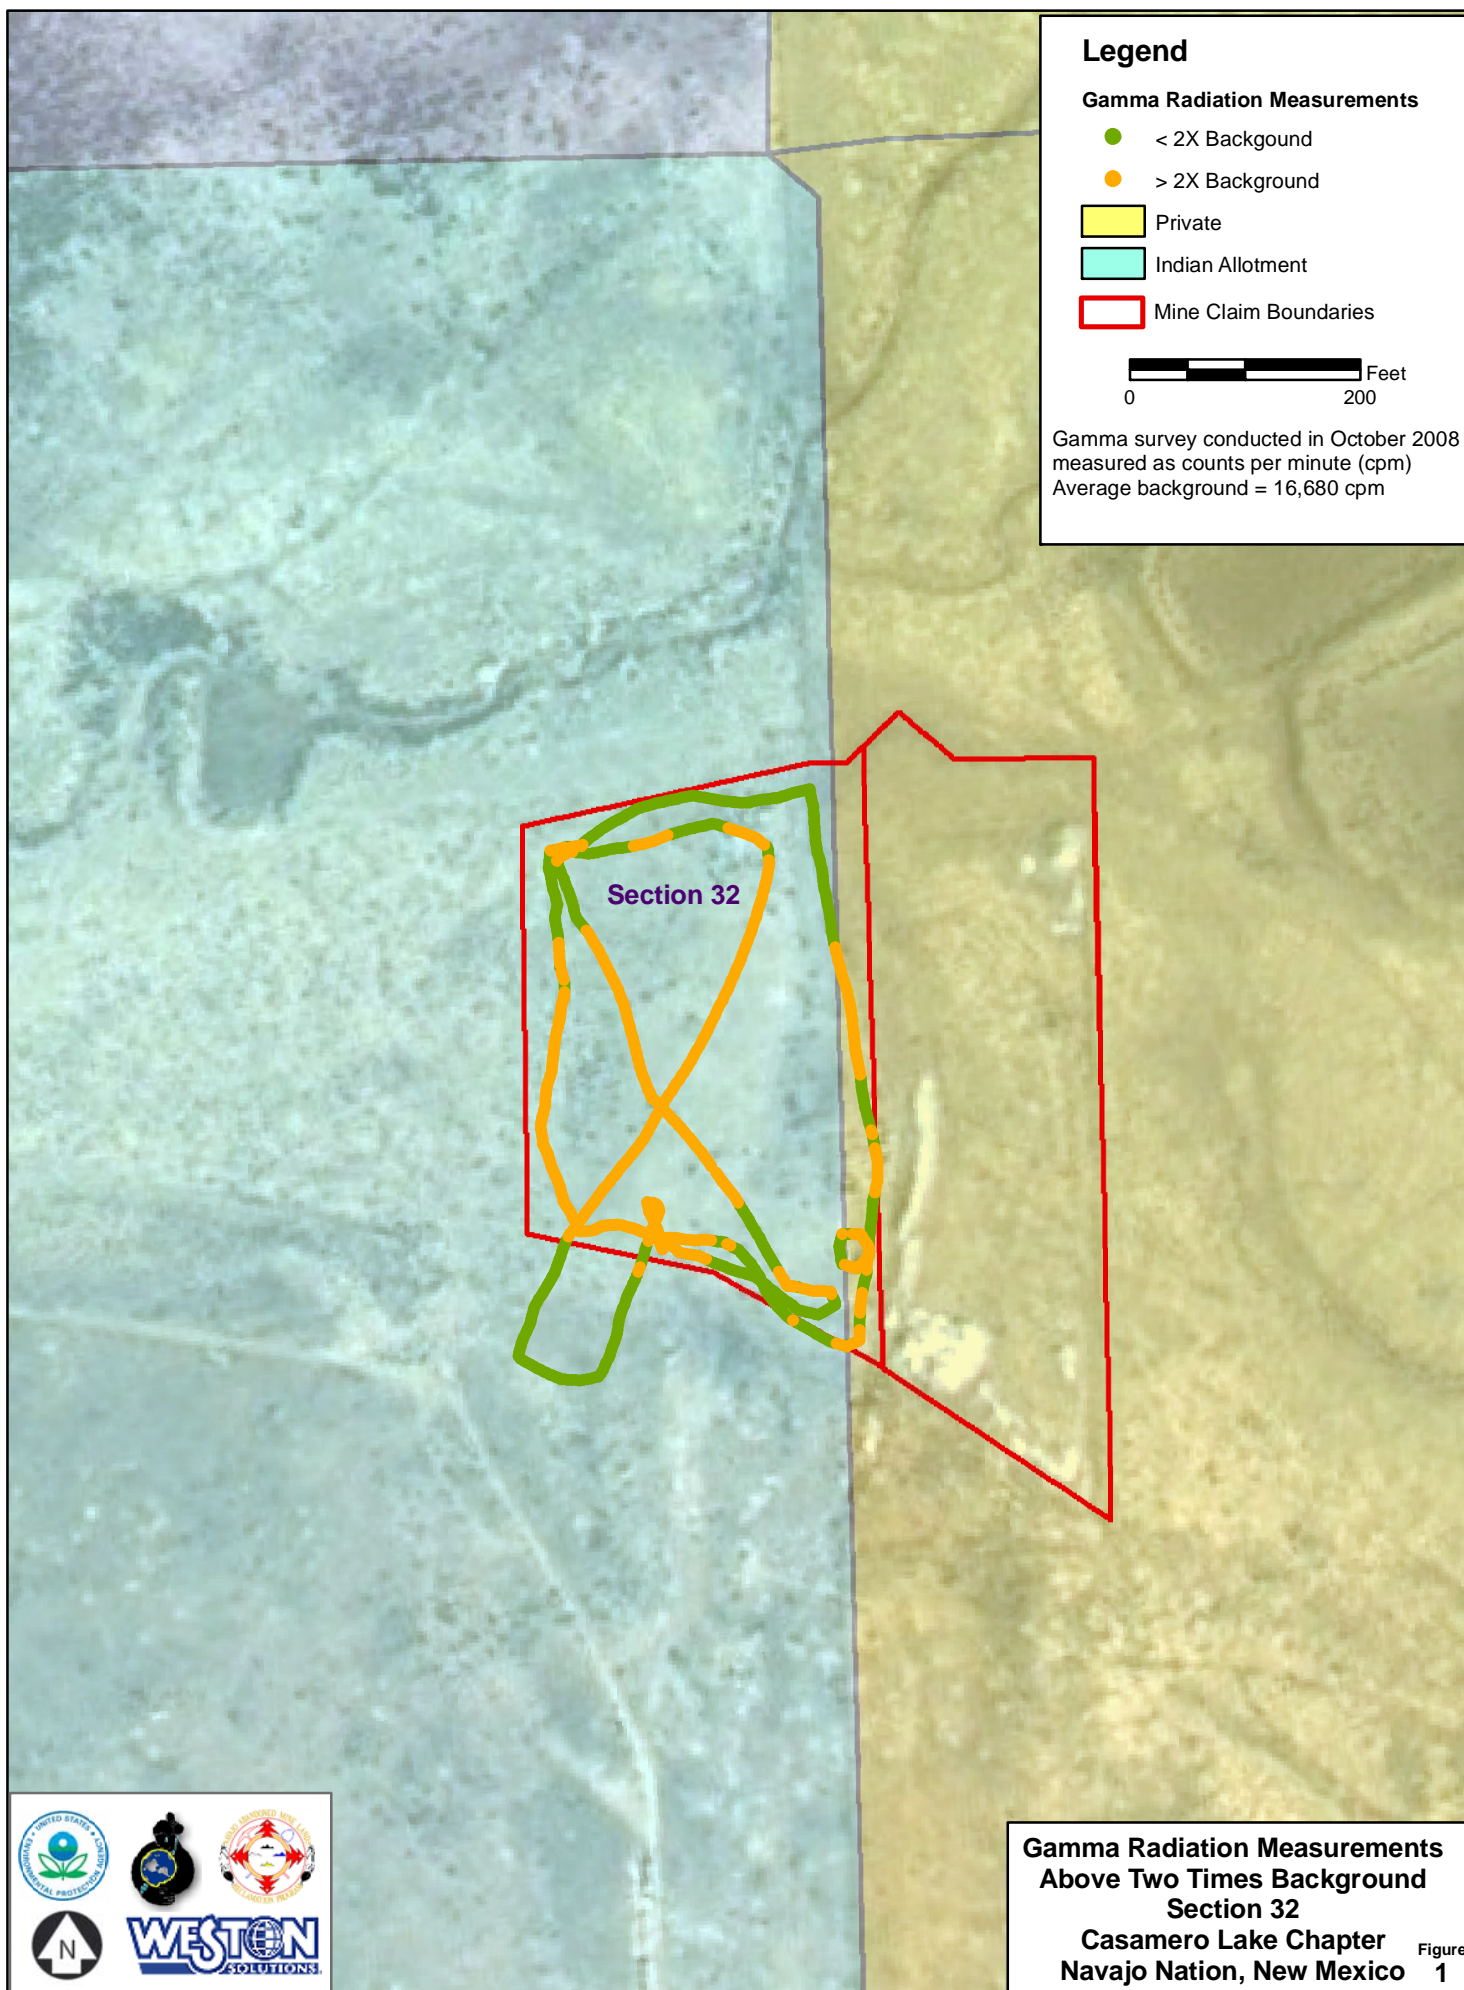
A total of 1,146 gamma radiation measurements were collected from mine sites, ranging from 10,689 cpm to 180,367 cpm. The measurements are represented in Figures 1 and 2.

Gamma survey conducted in October 2008  
measured as counts per minute

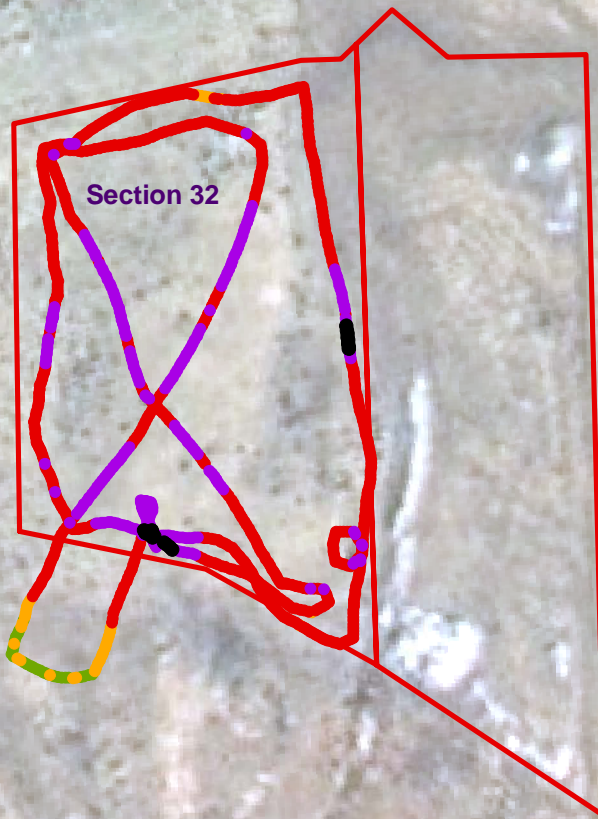
Figure 2

### Gamma Radiation Measurements
